MINE LAKE DAM
(Inventory Number NY 767)
ORANGE COUNTY,
NEW YORK.

INVENTORY NO NY 767

PHASE I INSPECTION REPORT,
NATIONAL DAM SAFETY PROGRAM

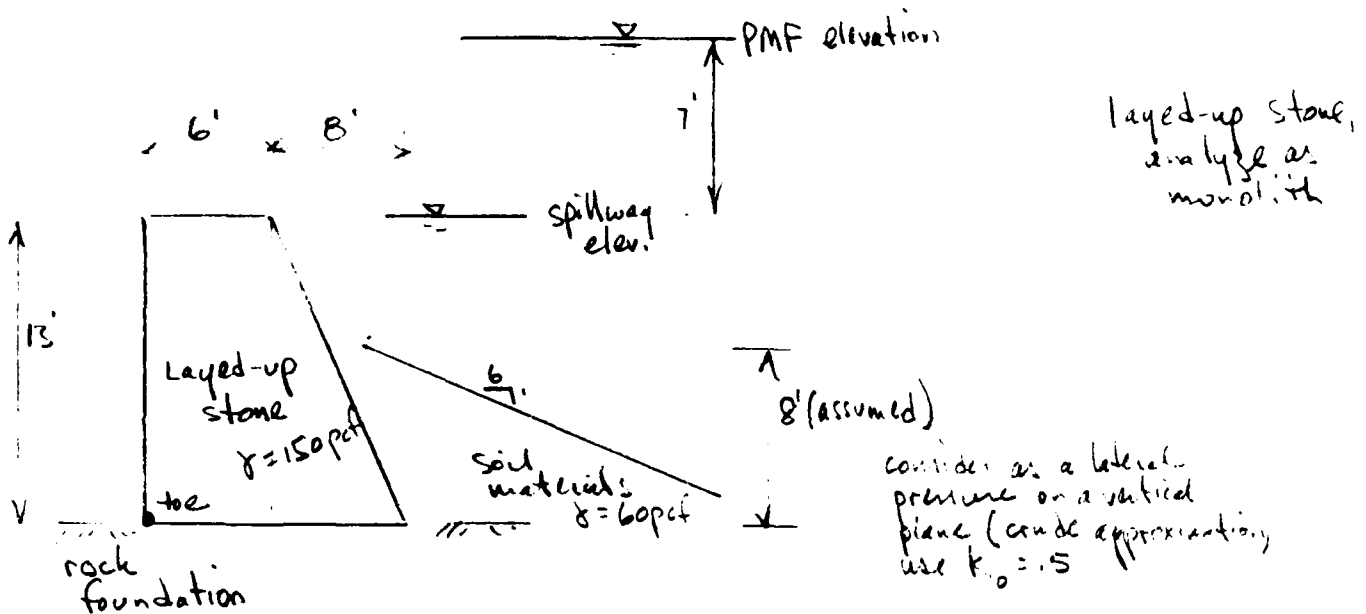
assumed cross-section, spillway area

(a) WL @ PMF elevation, uplift on 100% of base
(analyze for condition of no thru-dam leakage, pressure behind dam full hydrostatic)
